Asbestos Inspection

Clinton County Bridge 19

Blackford County Bridge 96

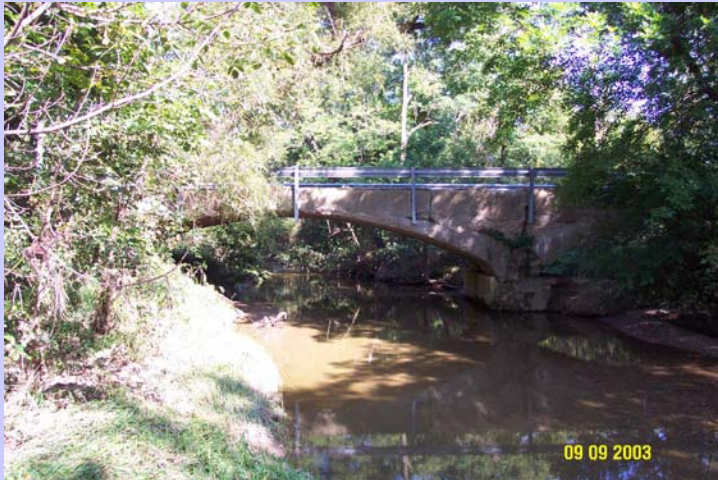
Bridge 19 was inspected for asbestos containing materials. A location map and report indicating the methodology of the sampling, location of samples taken, type, amount, summary and conclusions of the laboratory analyses. The laboratory analyses were conducted by Micro Air, Inc.

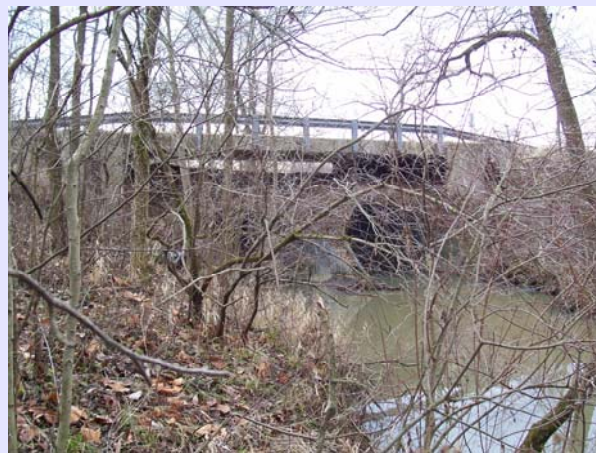
Bridge 96 was inspected for asbestos containing materials. A location map and report indicating the methodology of the sampling, location of samples taken, type, amount, summary and conclusions of the laboratory analyses. The laboratory analyses were conducted by Micro Air, Inc.
