## Wetland Delineation

Tipton County Bridge 93 Replacement

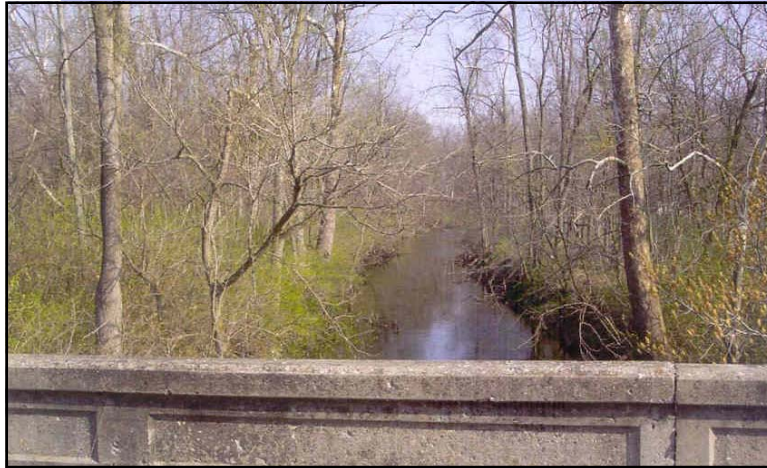
A wetland exists on the left (west) side of Duck Creek. The delineation was conducted to determine the boundaries of the wetland in relation to the construction limits of the project and to modify, if possible, the project to avoid this natural resource. We strive to avoid wetland impacts, where possible.

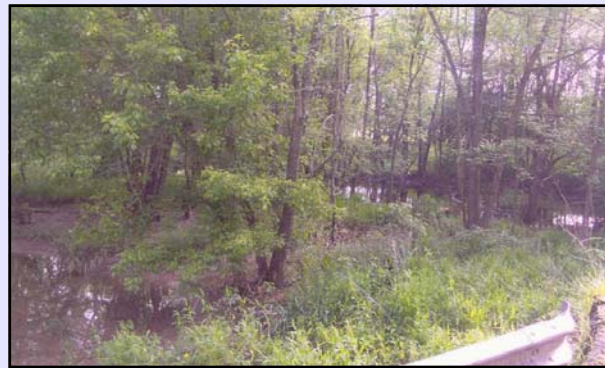
Rush County Bridge 116 and  
Overflow Structure 117 Replacements

Wetlands exist on the north and south side of these structures. A wetland delineation was conducted to determine the boundaries of these wetlands and calculate the overall impact to the site as a result of this project. Once the mitigation site is constructed, annual monitoring of the site to document the habitat's health will be conducted.

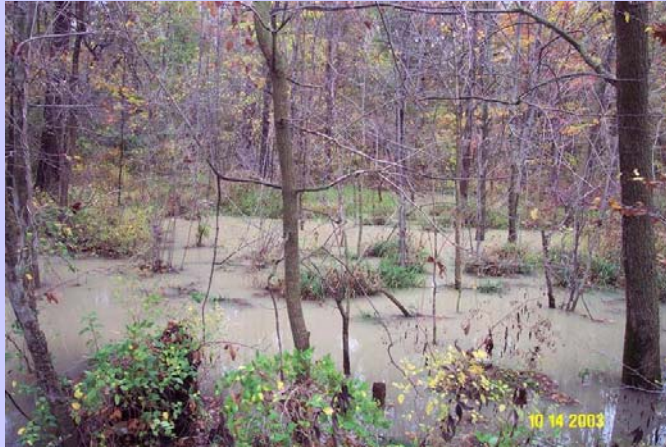
INDOT Roadway Improvements to the DNR Access  
Road Between SR 3 & County Road 74 West

One palustrine, forested, broad-leaved deciduous, temporarily flooded wetland (Cowardin) was identified on the north side of the Access Road. Impacts to this wetland will be dependent upon the design of the roadway improvements.

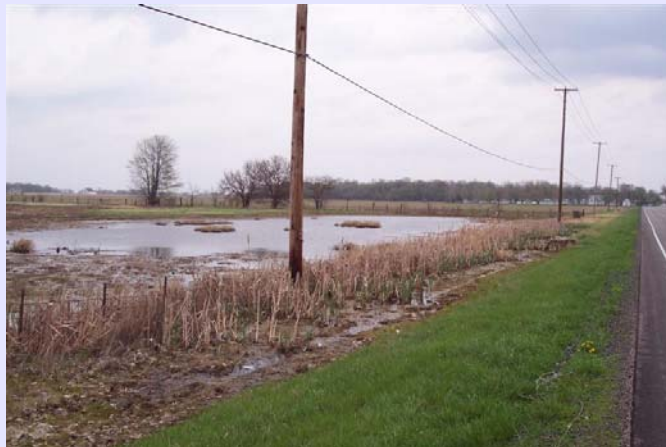
INDOT Roadway Improvements to SR 26 just east of SR 9

A wetland exists along the north side of SR 26 just east of SR 9. After delineating the wetland, it was determined that this was an isolated wetland and documented as such
